ACS Towbar Systems B.V.

Refurbishment instructions for service kit operation handles

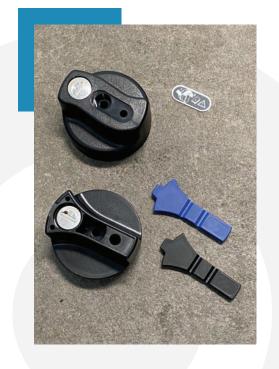
- 6. Place the new handle in the same position and orientation on the pinion as the old handle (see note 4). Do not forget to fit the central spring and push the handle tight onto the pinion.
- 7. Hold both, the detachable neck and the handle, and fasten with the supplied screw.

- 4. Before removing the handle take note of its orientation and position. Remove the handle and place the new handle in exactly the same position and orientation of the old one. Focus on the position of the red/green/yellow indicator and window position this will assist you in reassembling the handle properly.
- 5. The new handle is supplied with a lock in unlocked position. Please do not engage the lock before the new handle has been mounted properly!
